Galston Road, Hornsby Heights and Galston

Summary of investigations

JULY 2011

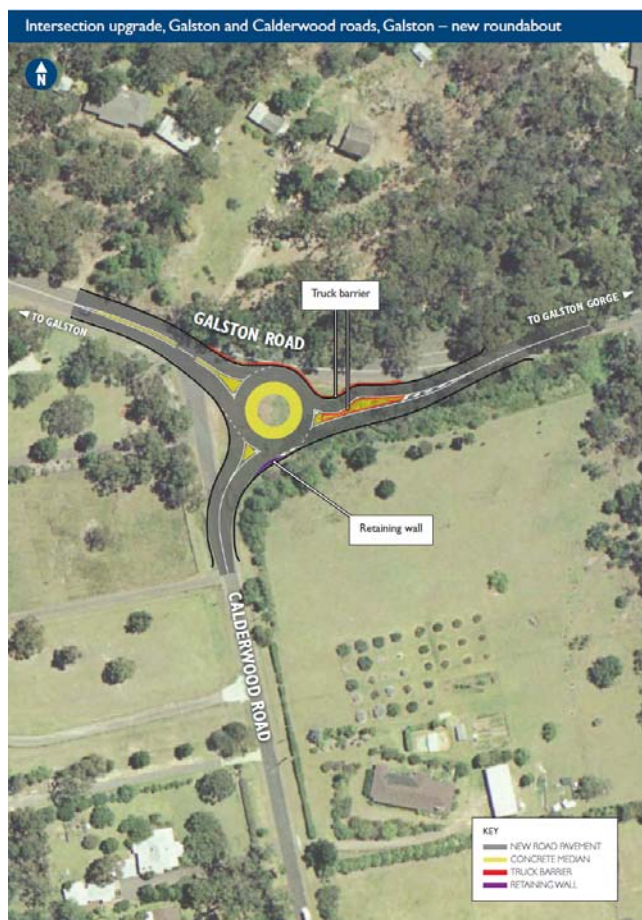
Figure 1: Proposed roundabout and truck barrier

- Installing an over-length vehicle monitoring (transportable infrared truck logger) and corresponding camera system on the eastern end of the gorge to monitor and take images of over-length vehicles.
- Installing an over-length vehicle monitoring system (transportable infrared truck logger) on the western end of the gorge to measure vehicle length and trigger a sign with flashing lights to warn the drivers of specific over-length vehicles to turn around and not proceed to the gorge.
- Upgrading the intersection of Galston and Calderwood roads, Galston by replacing the existing T-intersection with a roundabout.
- Constructing a truck facility on the departure side of the proposed roundabout to prevent the passage of eastbound heavy vehicles greater than 7.5 metres beyond the intersection.

A roundabout and associated truck facility are proposed to deter long vehicles likely to get stuck if they proceed along Galston Road east of the Calderwood Road intersection.

The concept design for the truck facility/barrier incorporates a series of tight curves. This would make the passage of an over-length vehicle very difficult. It would also pose a safety risk to other road users.

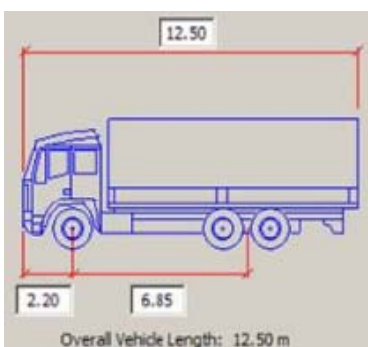
4.2.3 Vehicles which failed the simulation

The simulation indicates that the vehicle types below can not navigate the bends of the Gorge without incident:

As illustrated above, a 9.95 metre long truck with an excellent (high) steering lock angle could pass through the Gorge easier than a slightly shorter truck with a moderate (medium) steering lock angle. The turning paths of the above vehicles are attached in Appendix C.

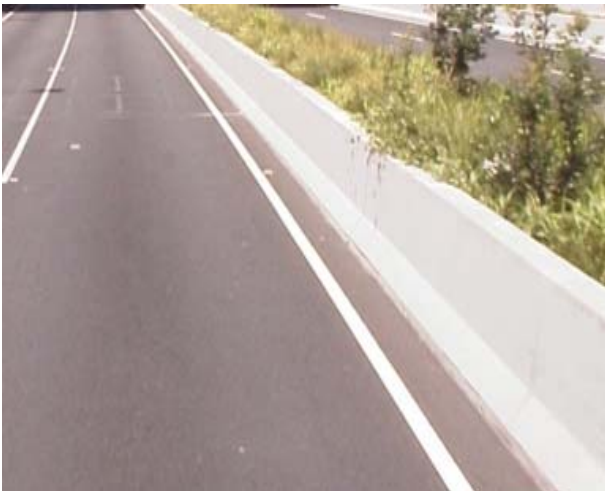
Concrete barrier

A standard type F barrier in conjunction with the 10-13% approach grade for westbound traffic would obstruct driver vision for vehicles entering the roundabout and would therefore pose a road safety hazard, reducing road user safety.

- **Concrete barrier** – Likelihood of rider impacting the barrier square on is high. Risk of death or severe injury to the rider is also high.
- **Elsholz redirective kerb** - Lower barrier height would result in moderate risk of death or injury due to impact with the kerb. Possibility the rider could be flung into the opposing traffic.
- **Standard kerb** – The risk of death due to impact is low.

- **Concrete barrier** – Likelihood of the car crashing head on into the barrier is high. Risk of the car being a 'write-off' is high. Risk of severe injury to the driver/any passengers is high.
- **Elsholz redirective kerb** – Likelihood of significant damage to the car on impact with the kerb is high. Moderate injuries are likely to be sustained by the driver/any passengers.
- **Standard kerb** – The risk of injury to the driver/any passengers is low. It is likely some damage to the vehicle would be sustained.
